**ADMINISTRATION & OPERATIONS CENTER  
BILL FARMER SHERIFF**

# Old Walmart + Electrical Upgrade = New 9-1-1 Center

Sumter County, Florida improves public safety when it gives a former department store a thorough makeover

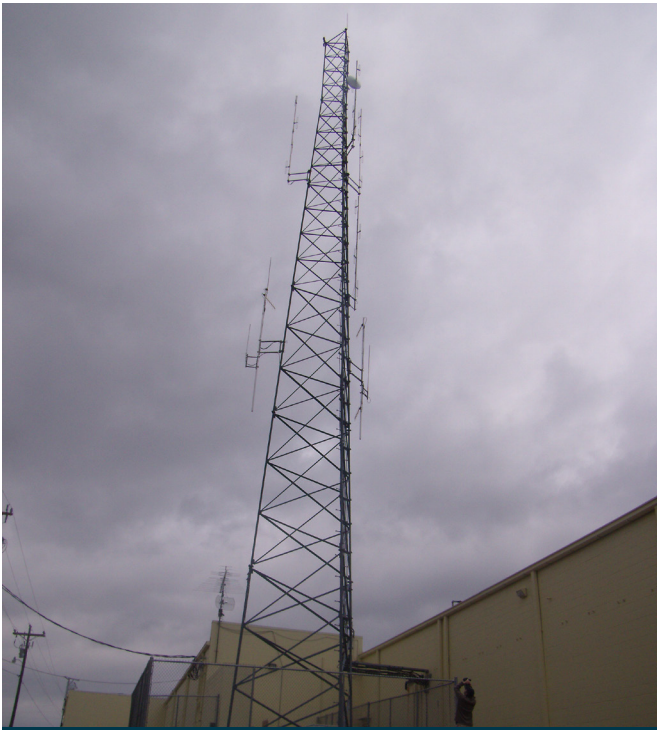
FIGURE 1.

The 121-ft. tower built for the Sumter County Sheriff's Department communications center serves 9-1-1, fire, police and other emergency services for the county, as well as most local communities. When erected in 2007, the tower was grounded independently from the communications center's grounding system, a practice with potentially serious consequences.

- The new transmission tower also had its own independent grounding system consisting of an electrode and a ring ground that was not directly connected to the building's service entrance ground. Again, independent grounds should not be used, since, in communications systems, they are a fertile source of noisy ground-loop currents. Thompson also found that coaxial cable leads connecting antennas on the tower with the comm center were not grounded. Had lightning struck the tower, it would have had a direct, high-conductivity path into communications equipment.

A 121-ft. communications tower, **Figure 1**, was erected in 2007, and the 9-1-1 center was occupied the following year, including fire, police, weather-alert and other public-safety communications facilities.

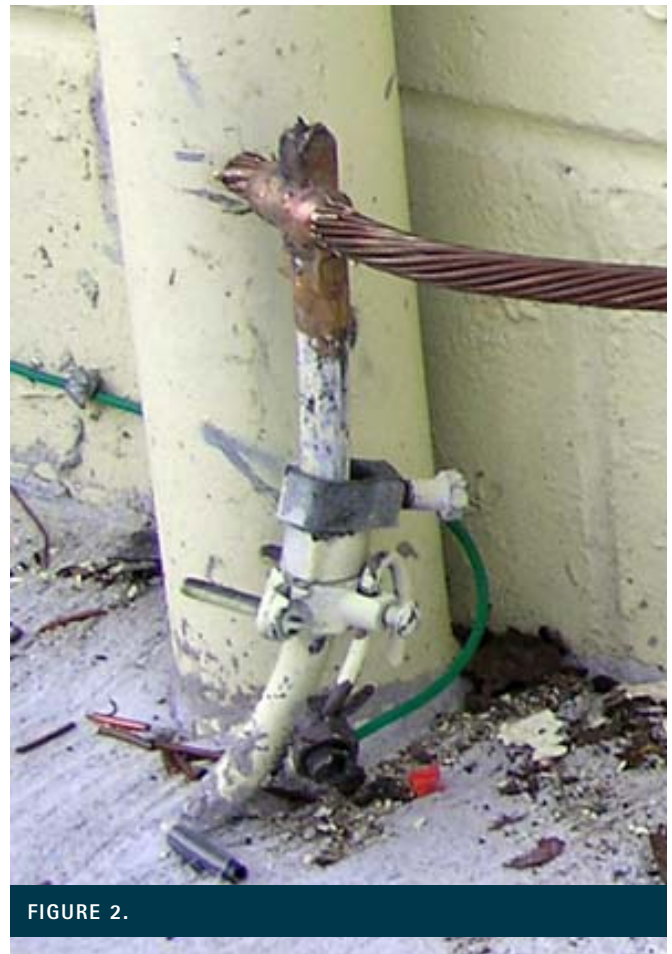
FIGURE 2.

When combining the former Walmart's two power services, electricians transferred the grounding system to one existing galvanized steel electrode. Ground resistance at the electrode was 230  $\Omega$ , which is far too high for a sensitive communications facility.

- The grounding electrode system for the building itself consisted of a single galvanized steel electrode installed in the 1970s, **Figure 2**. Thompson measured resistance to ground at the electrode and found that it registered 230  $\Omega$ , which is way above the five-ohm maximum cited in IEEE recommended

practices and nearly ten times higher than the 25-Ω limit noted in the National Electrical Code® for a single electrode.

store. Thompson bonded to the old rod, but used the deep, low-resistance electrodes and ring at the nearby tower as the primary earth connection.

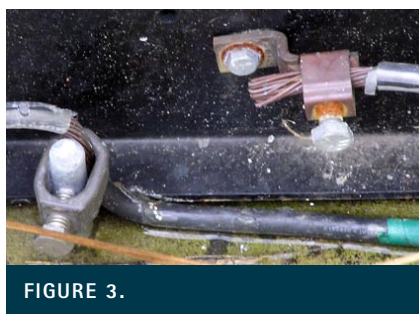
FIGURE 3.

- The two emergency generators were also independently grounded. The grounding conductor bond at one generator was in questionable condition, Figure 3, and the other one used an automotive hose clamp (a fairly common but definitely very poor practice).

Two emergency generators were independently grounded via galvanized steel electrodes, one of which is shown at the left of the photo. Bonded connections were not in good condition, and one (not shown) utilized a commercial hose clamp to secure the connection.

**Emergency Generators.** The facility has two propane-fueled emergency generators, rated at 150 kVA and 40 kVA. Thompson ran AWG 4/0 copper from the ring ground to the generators, overlapping flimsy existing grounds, Figure 11. He also grounded the generators' propane fuel line, securing all conductors to the concrete slabs with Hilti nails, which are stronger and more tamper-resistant than screws.

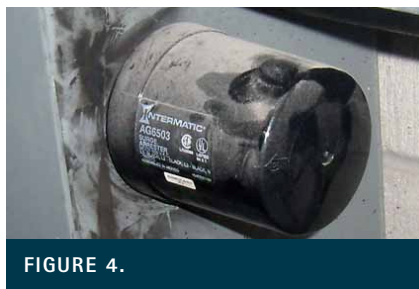
FIGURE 4.

- Panels and sub-panels in the main electrical closet were protected by a combination of lightning arrestors and surge protection devices (SPDs). It isn't known if lightning ever did enter the building, but at least one of the lightning arrestors at the service entrance was damaged and one of them had been replaced (note the black mark on the electrical panel, Figure 4, showing evidence of the device failure). SPDs are supposed to

shunt voltage spikes to ground. They can't do that when they're not well grounded.

Soot smudges indicate that this SPD on a sub-panel had sustained some damage, possibly lightning-induced. SPDs must be very well grounded in order to work. This one wasn't. The building's two distribution transformers were supposedly grounded to building steel. However, building steel was not bonded to the building's old grounding electrode, as it should have been.

- Technical Electric Systems fitted panels and sub-panels with new SPDs, examples of which are shown in Figures 12 and 16. The intent here was to provide multi-layered SPD protection, i.e., at the service entrance, at the main distribution panel indoors, at sub-panels and, finally, at load points such as computer terminals downstream. Surge protection was installed by Mike Henry of Technical Electric Systems, Inc.

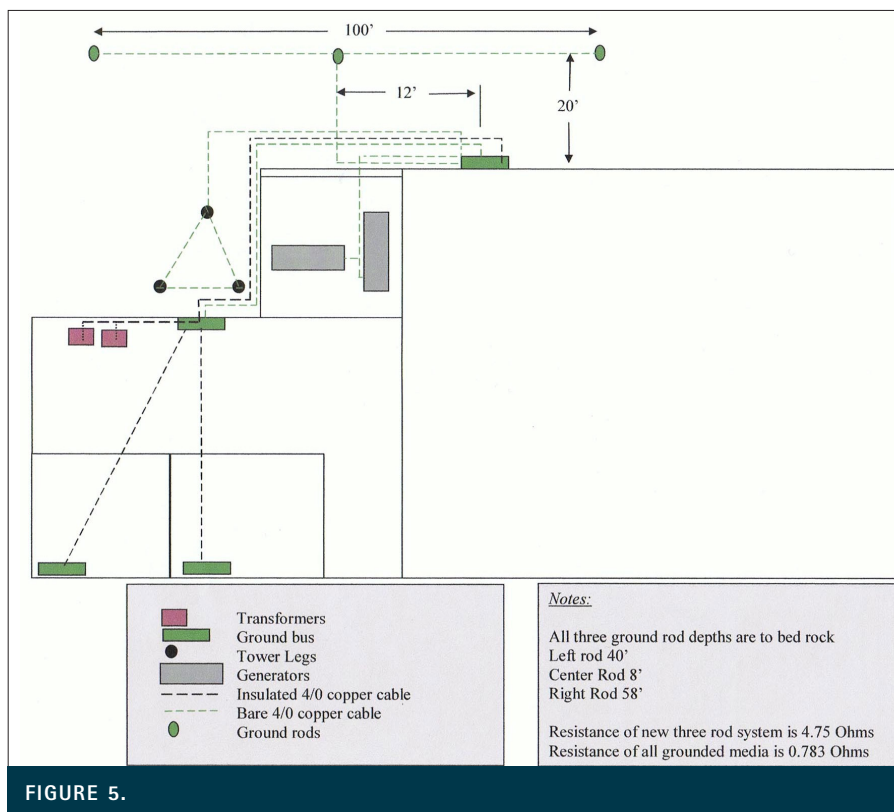
FIGURE 5.

Important improvements to the communications center's new grounding system included extremely low resistance thanks to three deep electrodes and a robust copper ring ground. Equally important are the systems large-gauge conductors, use of proper bonding practices throughout, and a well-engineered layout based on a central grounding bar.

Mr. Thompson designed the new grounding system shown in Figure 5. Chief Deputy Sheriff Jordan authorized work to begin immediately. The cost, between \$38,000 and \$40,000, was tiny compared with the improved public safety it bought for Sumter County's 98,000 inhabitants.

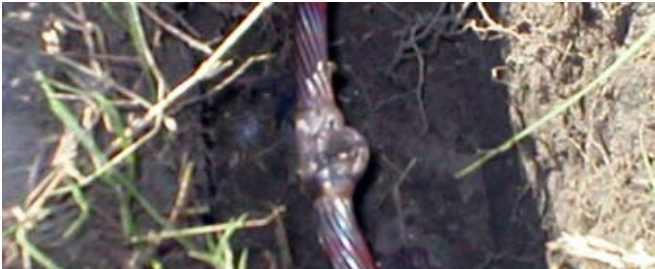
FIGURE 6.

Three electrodes, one at each tower leg, were exothermically bonded to an AWG 4/0 bare copper ring ground. The ring and its deep-driven electrodes served as the main earth connection for the new system.

**Transmission Tower & Ring Ground.** Thompson began the upgrade at the tower. He installed three new copper-clad electrodes, one at the base of each tower leg, at depths of 40 ft., 8 ft. and 58 ft., respectively. The deep electrodes would ensure low resistance. He exothermically welded an AWG 4/0 bare copper ring ground to the electrodes, Figure 6, then ran AWG 4/0 pigtailed to the tower and external system elements

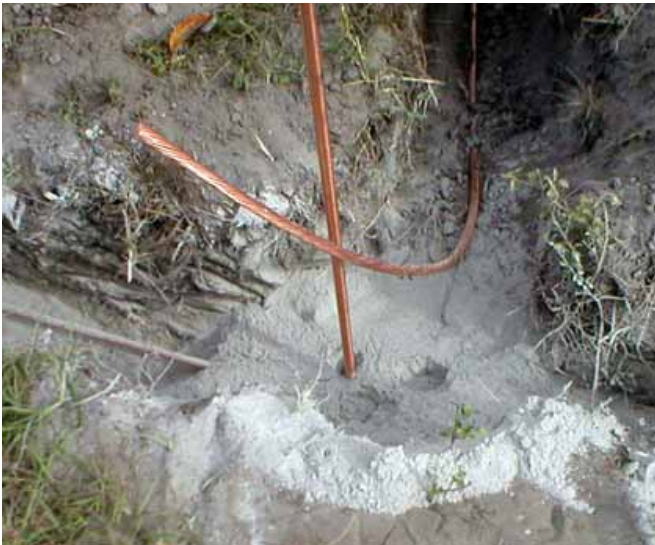
FIGURE 7.

The electrodes, ring-ground and other conductors were surrounded by bentonite, which lowers resistance by providing good contact with the soil. It also protects copper over a wide range of soil conditions. A portion of the ring is at lower left. The copper-clad electrode, center, is ready to be welded to one of several AWG 4/0 bare copper pigtailed that extend to the tower legs and external system elements.

and surrounded the conductors with bentonite, Figure 7. Bentonite is a clay mineral that expands when moistened, making good contact to earth. It also protects copper against corrosion over a wide range of soil conditions.

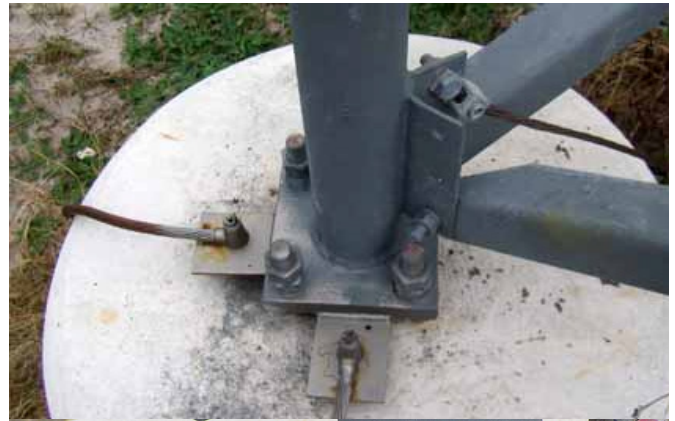
FIGURE 8.

AWG 4/0 conductors extending from the ring ground were exothermically bonded to 1/4-in steel tabs that had been welded to each tower leg. Conductors are bare copper. Spray paint protects the underlying steel.

To bond grounding conductors to the tower legs, Thompson first welded 1/4-in steel tabs to the tower legs, then exothermally welded the 4/0 to them, Figure 8. (The welds were sprayed with protective paint.) The bonds are robust and are easy to inspect and service if needed.

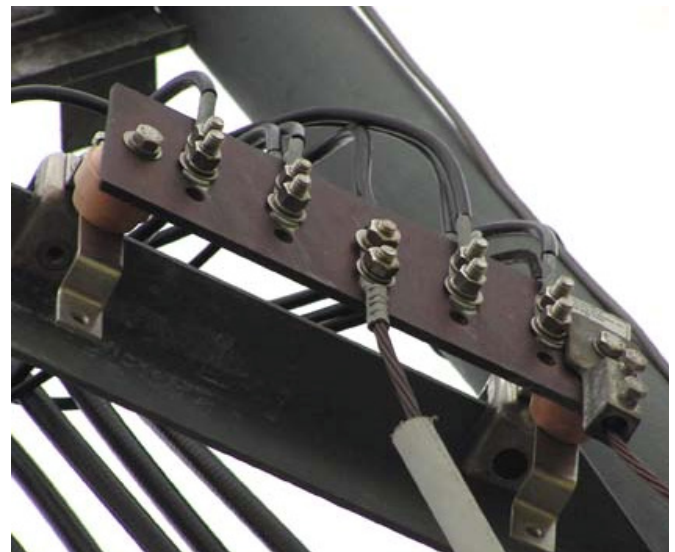
FIGURE 9.

Shielding on coax is grounded by leads (thin conductors, upper left) to the copper ground bar shown in the photo. The bar itself is grounded via a conduit-enclosed, vertical conductor that extends to the tower's ring ground, below. Conductors are run as straight downward as practical to direct lightning energy toward earth. Double lugs and lock nuts on the ground bar add reliability in this difficult-to-service location.

**Coax Shields.** Coaxial cables originating at antennas on the tower weren't grounded, so Thompson installed a copper ground bar on the tower above the point where the cables make a 90° turn to the ice bridge and toward the building bulkhead, Figure 9. He bonded short copper leads to shields on the waveguides, then double-lugged them to the ground bar. The leads slope downward to keep the path toward earth as direct as practical. Similarly, a length of 4/0 (encased in PVC conduit) extends straight down from the ground bar to the buried ring.

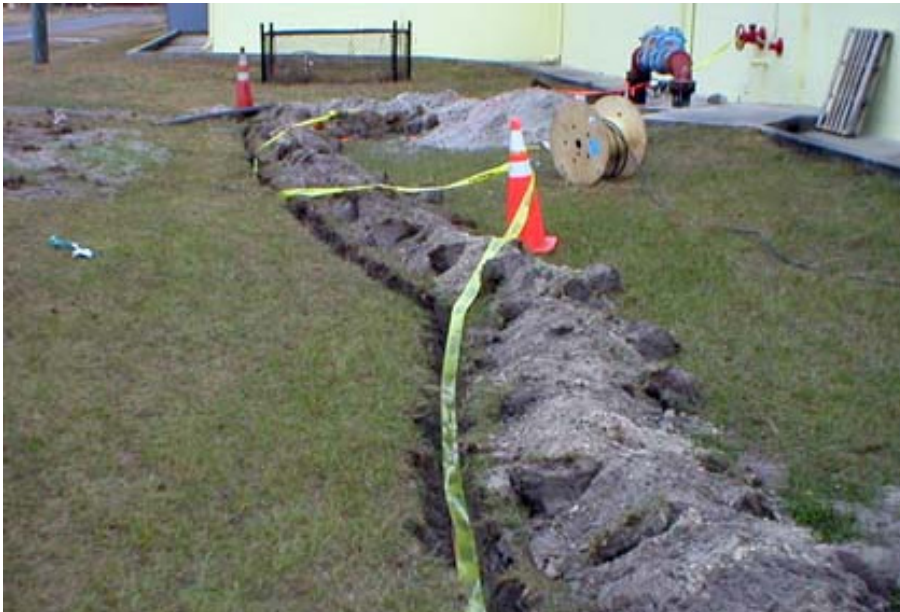
FIGURE 10.

A 100-ft. trench containing AWG 4/0 bare copper constructed approximately 20 ft. behind and parallel to the main building. The buried copper directs lightning energy away from the tower and the building.

**Horizontal Electrode.** Thompson laid 100 ft. of AWG 4/0 bare copper grounding conductors in a two-foot-deep trench running parallel to, and approximately 20 ft. behind, the main building, Figure 10. The copper, which is bonded to the ring ground, serves as a horizontal grounding electrode to direct lightning energy from away from the tower and building. The buried copper may also have helped reduce the system's ground resistance.

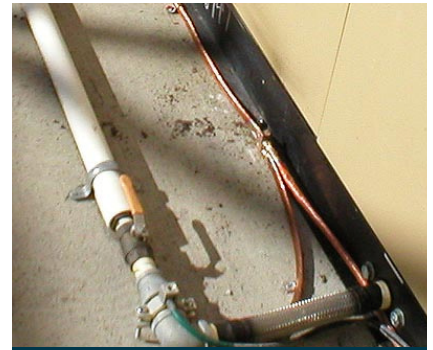
FIGURE 11.

New AWG 4/0 grounding conductors connect the ring ground and the emergency generators. A conductor is also bonded to the generator's propane fuel line. Tamper-resistant Hilti nails secure the conductors to the concrete slab.

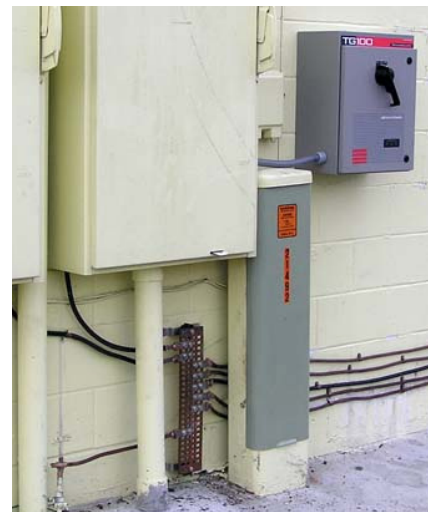
FIGURE 12.

All ground leads meet at a 1/4-in thick copper ground bar below one of the building's service entrance cabinets. Also bonded to the bar are the building's original ground rod, lower left, and two newly installed Transguard TG100 surge suppressors, one of which can be seen at upper right.

Connections from the ring and from all other grounding conductors, including the ground-neutral bonds in the service entrance, were routed to a 1/4-in. thick grounding plate mounted on standoffs on the building wall below the dual service entrance cabinets, Figure 12, which, in turn, was connected to the facility's main grounding bus - another copper plate - on the exterior wall below the waveguide entrance bulkhead, Figure 13. Also bonded to the lower ground bar was the building's original grounding electrode and two new Transguard TG100 SPD units, one for each service entrance cabinet. The TG100s are rated to 100 kA line-to-neutral and line-to-ground, and 200 kA per phase.

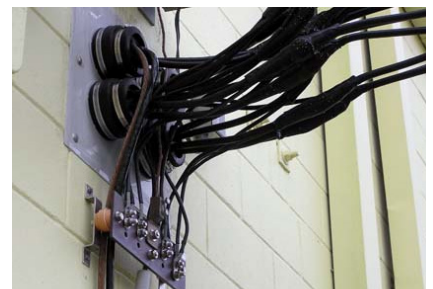
FIGURE 13.

The facility's main grounding bus is mounted on an exterior wall, directly beneath the waveguide bulkhead. The bus connects to the ground plate shown in Figure 12 and to the main indoor ground bus directly behind it.

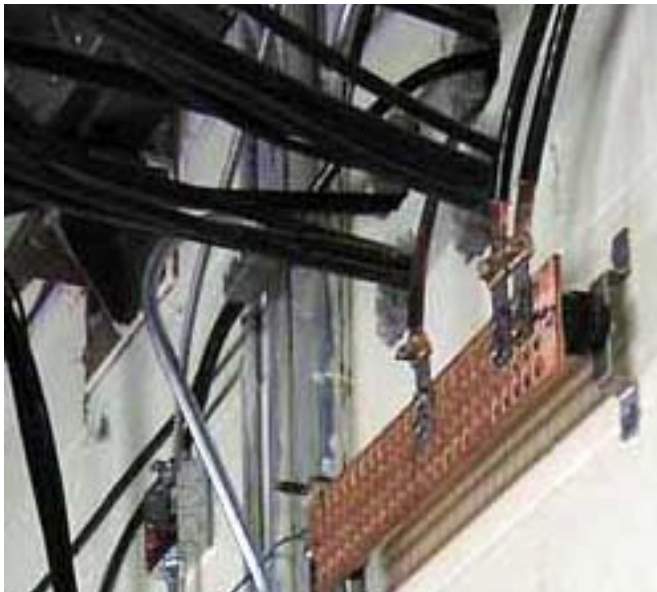
FIGURE 14.

The main indoor grounding bus is mounted approximately back-to-back with the main bus outside. It serves sub-panels and ground bars in equipment rooms. The four bulkhead penetrations can be seen directly above the bus. Grounding conductors from the transformers are threaded through one of those penetrations and are bonded directly to the main bus.

- He first installed a ground bar indoors, aligned approximately back-to-back with the main (outdoor) grounding bus,

Figure 14. It serves as the collection point for grounding conductors from panels, sub-panels and additional ground bars in equipment rooms.

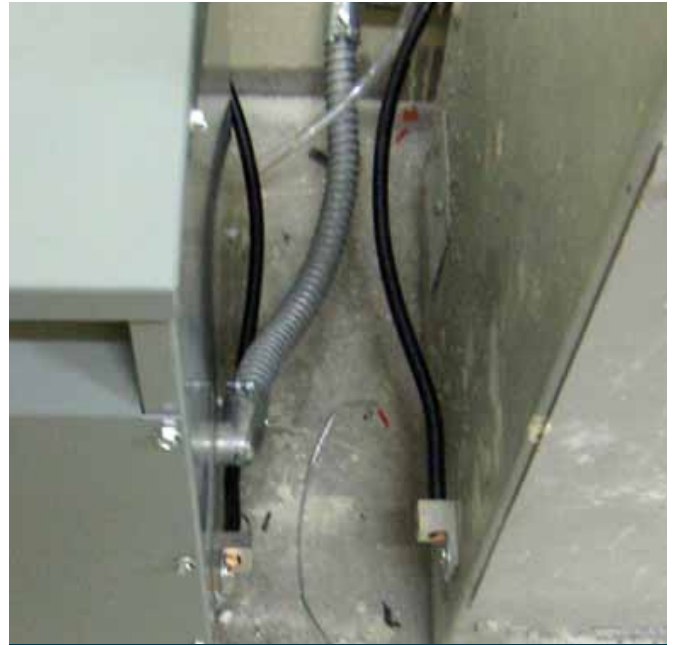
FIGURE 15.

Distribution transformers that had been "grounded" to building steel were properly bonded to the main outdoor grounding bus with AWG 4/0 copper (black cables at center).

- The site's two distribution transformers had been "grounded" to building steel, but the steel was not bonded to the grounding electrode. Thompson grounded them properly with AWG 4/0 copper, Figure 15, which he ran directly to the main facility grounding bus outside using one of the four bulkhead penetrations.

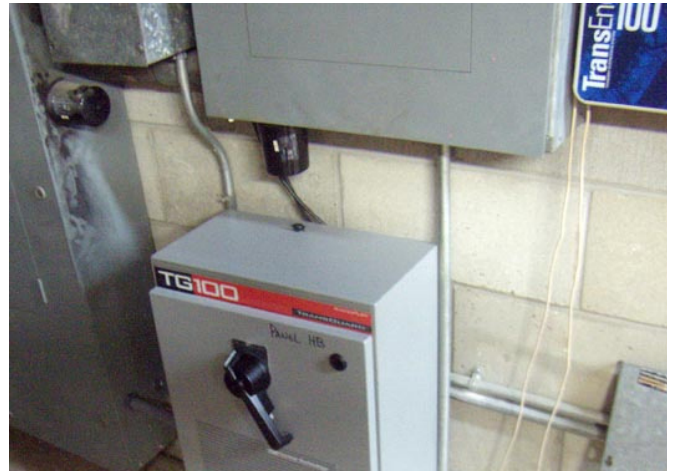
FIGURE 16.

The comm center's multi-layer surge protection is illustrated by the large-capacity TG100 SPD, which serves the entire electrical closet, and a smaller TS100, mounted on a sub-panel. Both are rated at 100 kA line-to-neutral and line-to-ground, and 200 kA per phase. Black modules are older SPD units which were left in place. Surge protection was installed by Mike Henry of Technical Electric Systems, Inc. Note the black mark on the electrical panel at far left, which shows where an old lightning arrester failed and was replaced at some time in the past.

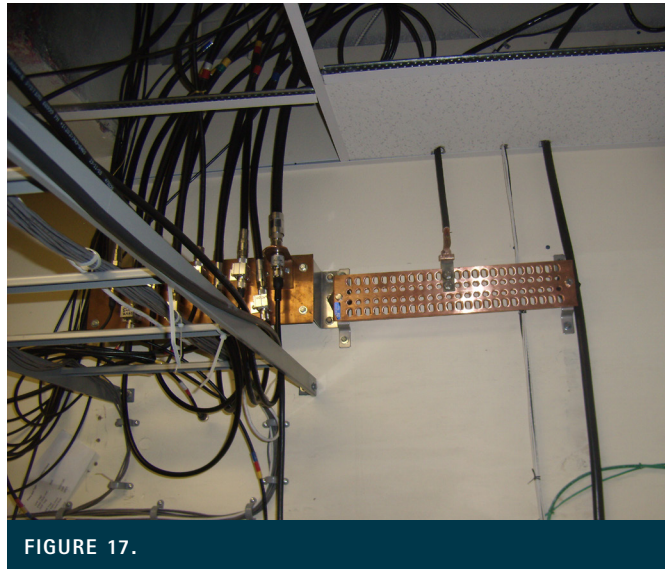
FIGURE 17.

A copper ground plate, right, collects equipment grounding conductors in the center's radio room. A separate plate, behind racks at left) is bonded to shields on coax cables entering from above.

- Lastly, Thompson attacked the hodgepodge of grounding that he, John West and Lieutenant Merritt had found in communications equipment rooms, on transmitters, routers, and other gear. He replaced the daisy-chained grounds with homeruns to grounding plates and installed a separate grounding plate for coax shields at the point where they enter the radio room, Figure 17. That provided redundant protection since the coax cables were also grounded at the tower (Figure 9), thus providing two points at which lightning energy could be shunted away from communications equipment.

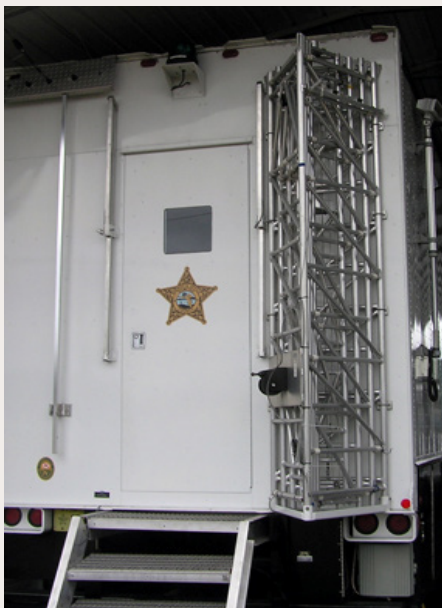
The Sumter County Sheriff's Department does not rely solely on its new communications center in times of emergency. When times get really rough, such as during hurricanes, the department sends out its mobile 9-1-1 center, an 18-wheeler equipped with all the communications gear needed to handle protracted blackouts. The mobile unit mounts several collapsible antennas, and yes, it is fitted with provisions to attach a low-resistance grounding electrode. Even here, grounding is recognized as the key to reliable communications.
